Debris/Ice/TPS Assessment And Photographic Analysis For Shuttle Mission STS-36

April 1990

DEBRIS/ICE/TPS ASSESSMENT
AND
PHOTOGRAPHIC ANALYSIS
OF
SHUTTLE MISSION STS-36

February 28, 1990

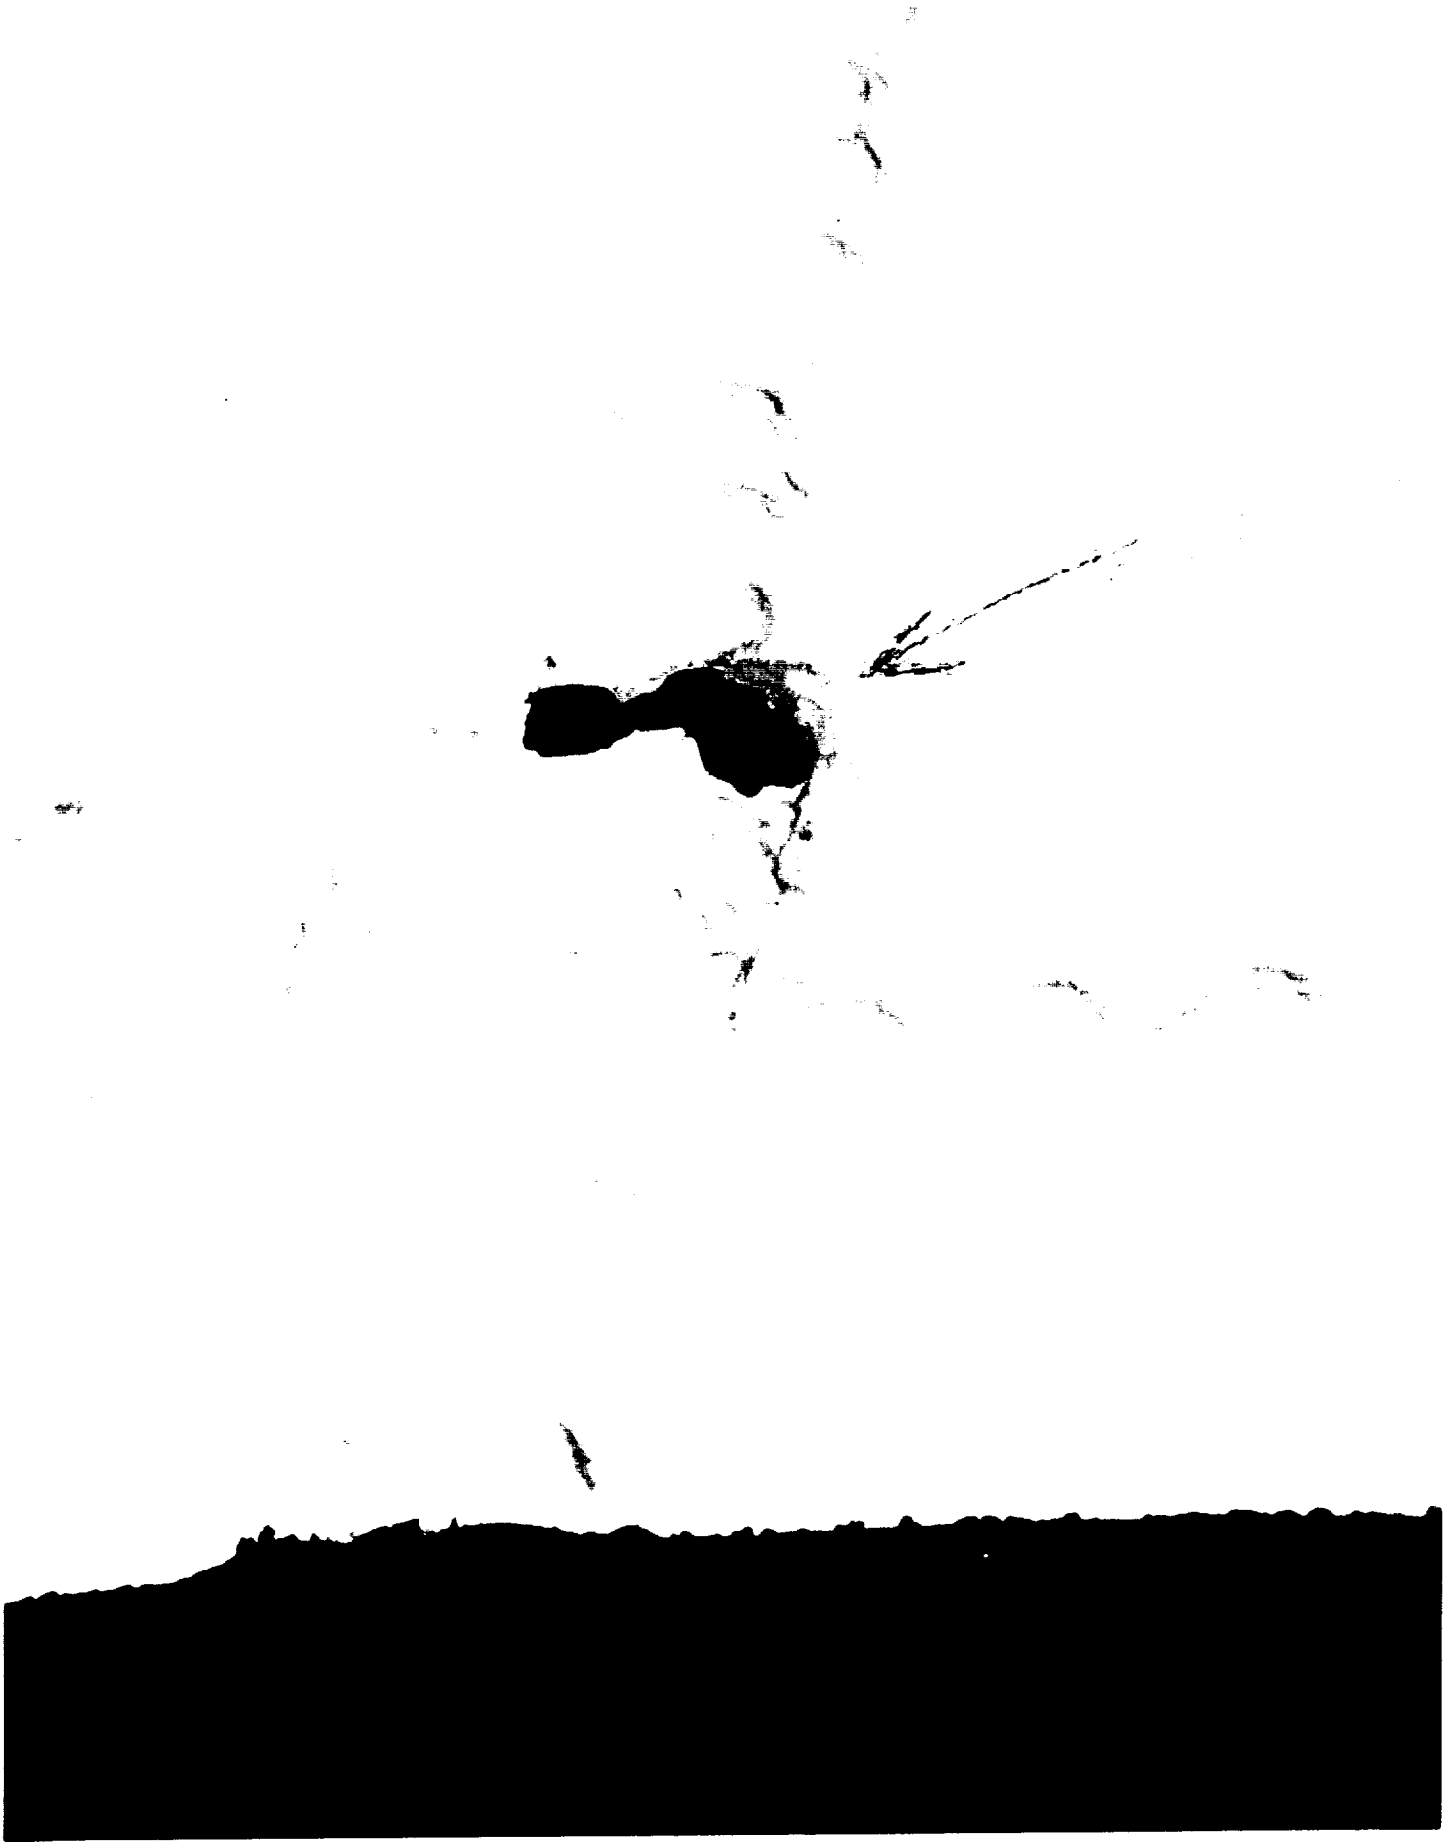
Missing Hypalon paint with some layers of MSA-2 attached was
located just above the 318 ring near the -Y axis

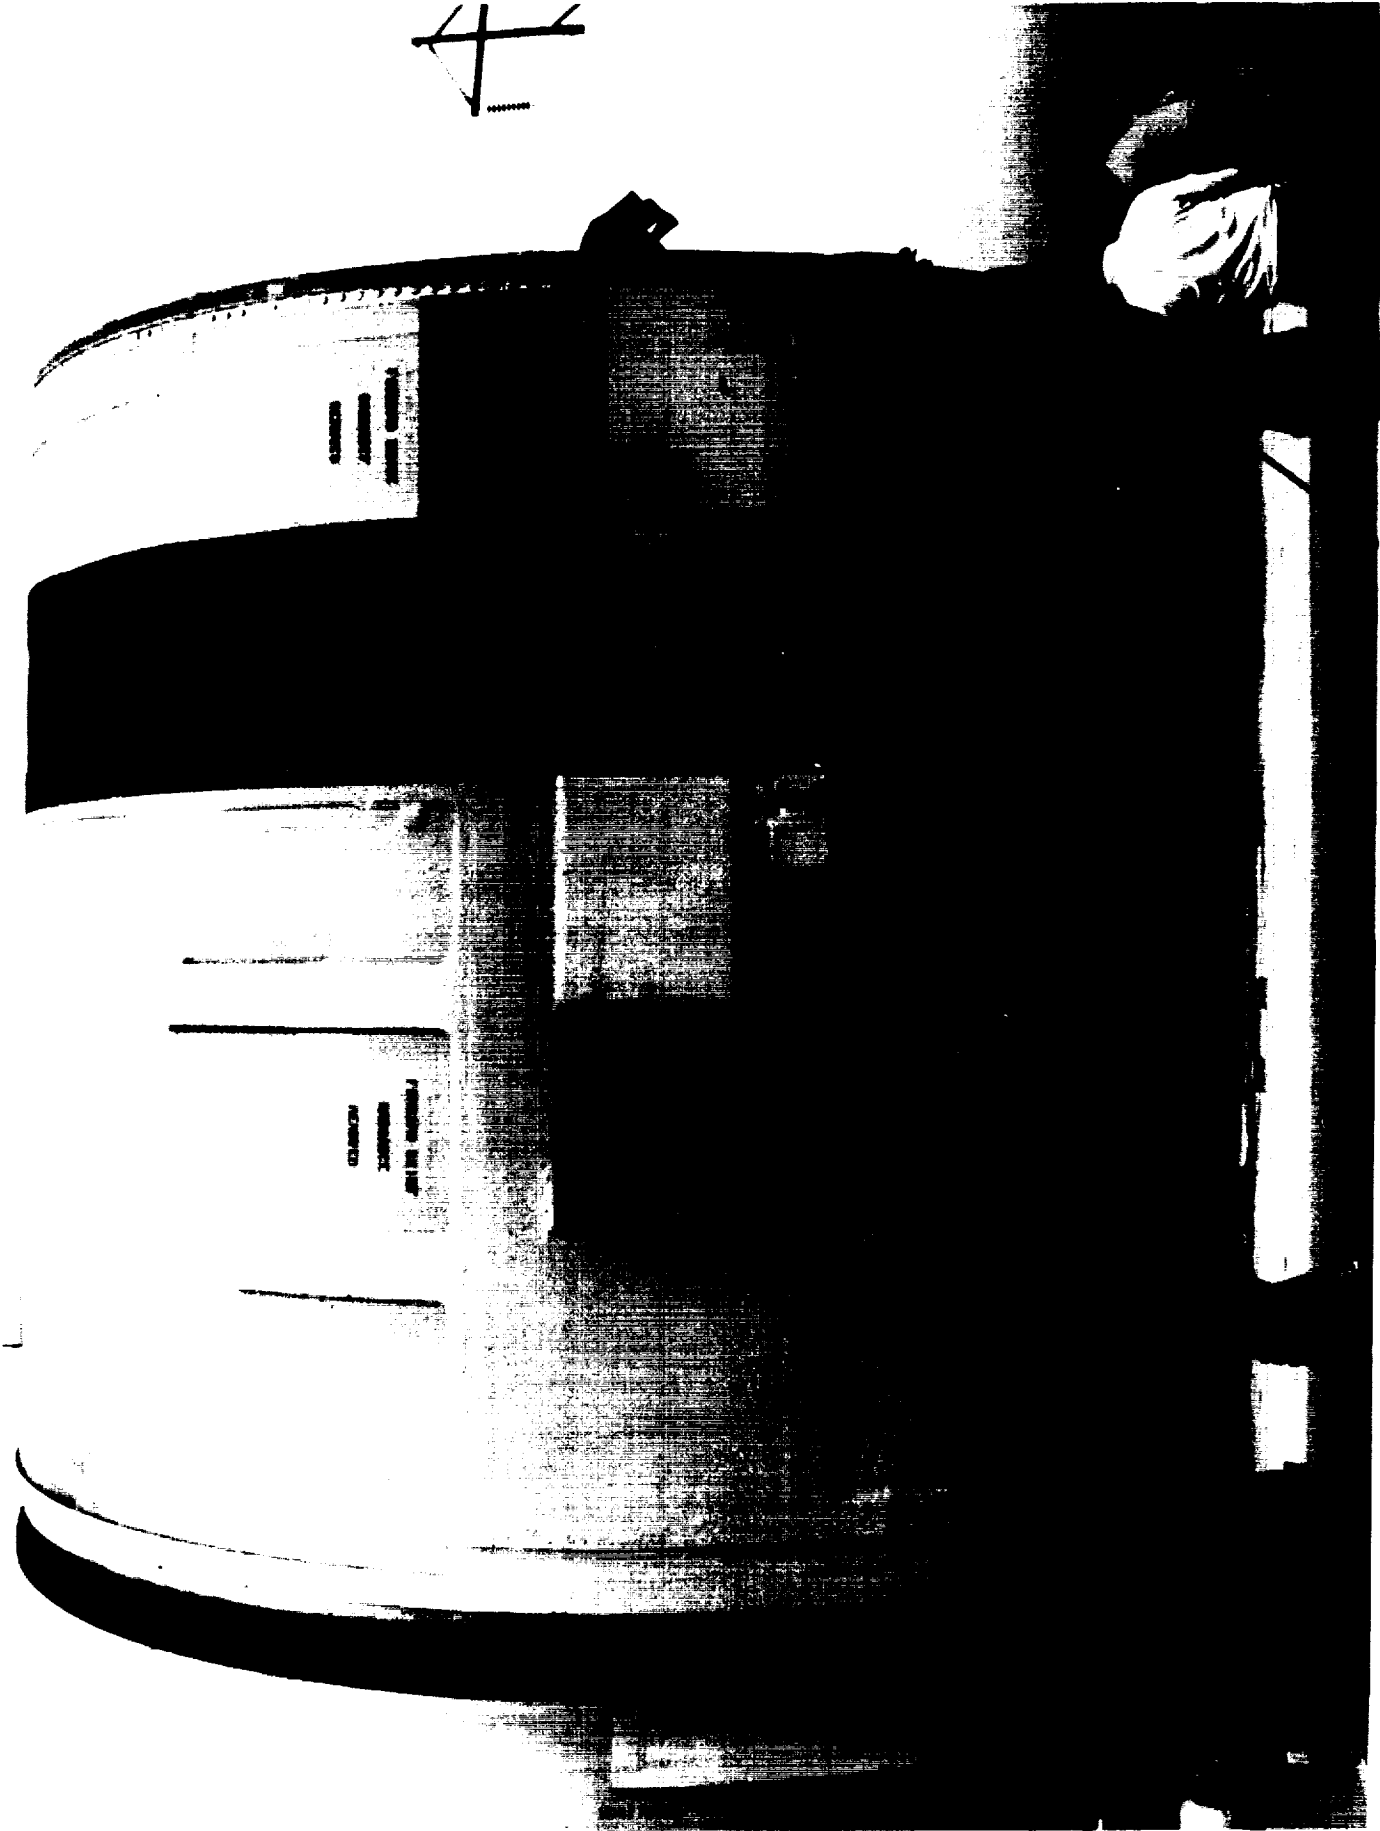
Overall view of LH forward skirt with Hypalon paint blistering.
Note ascent aeroheating scorch mark forward of thrust fitting

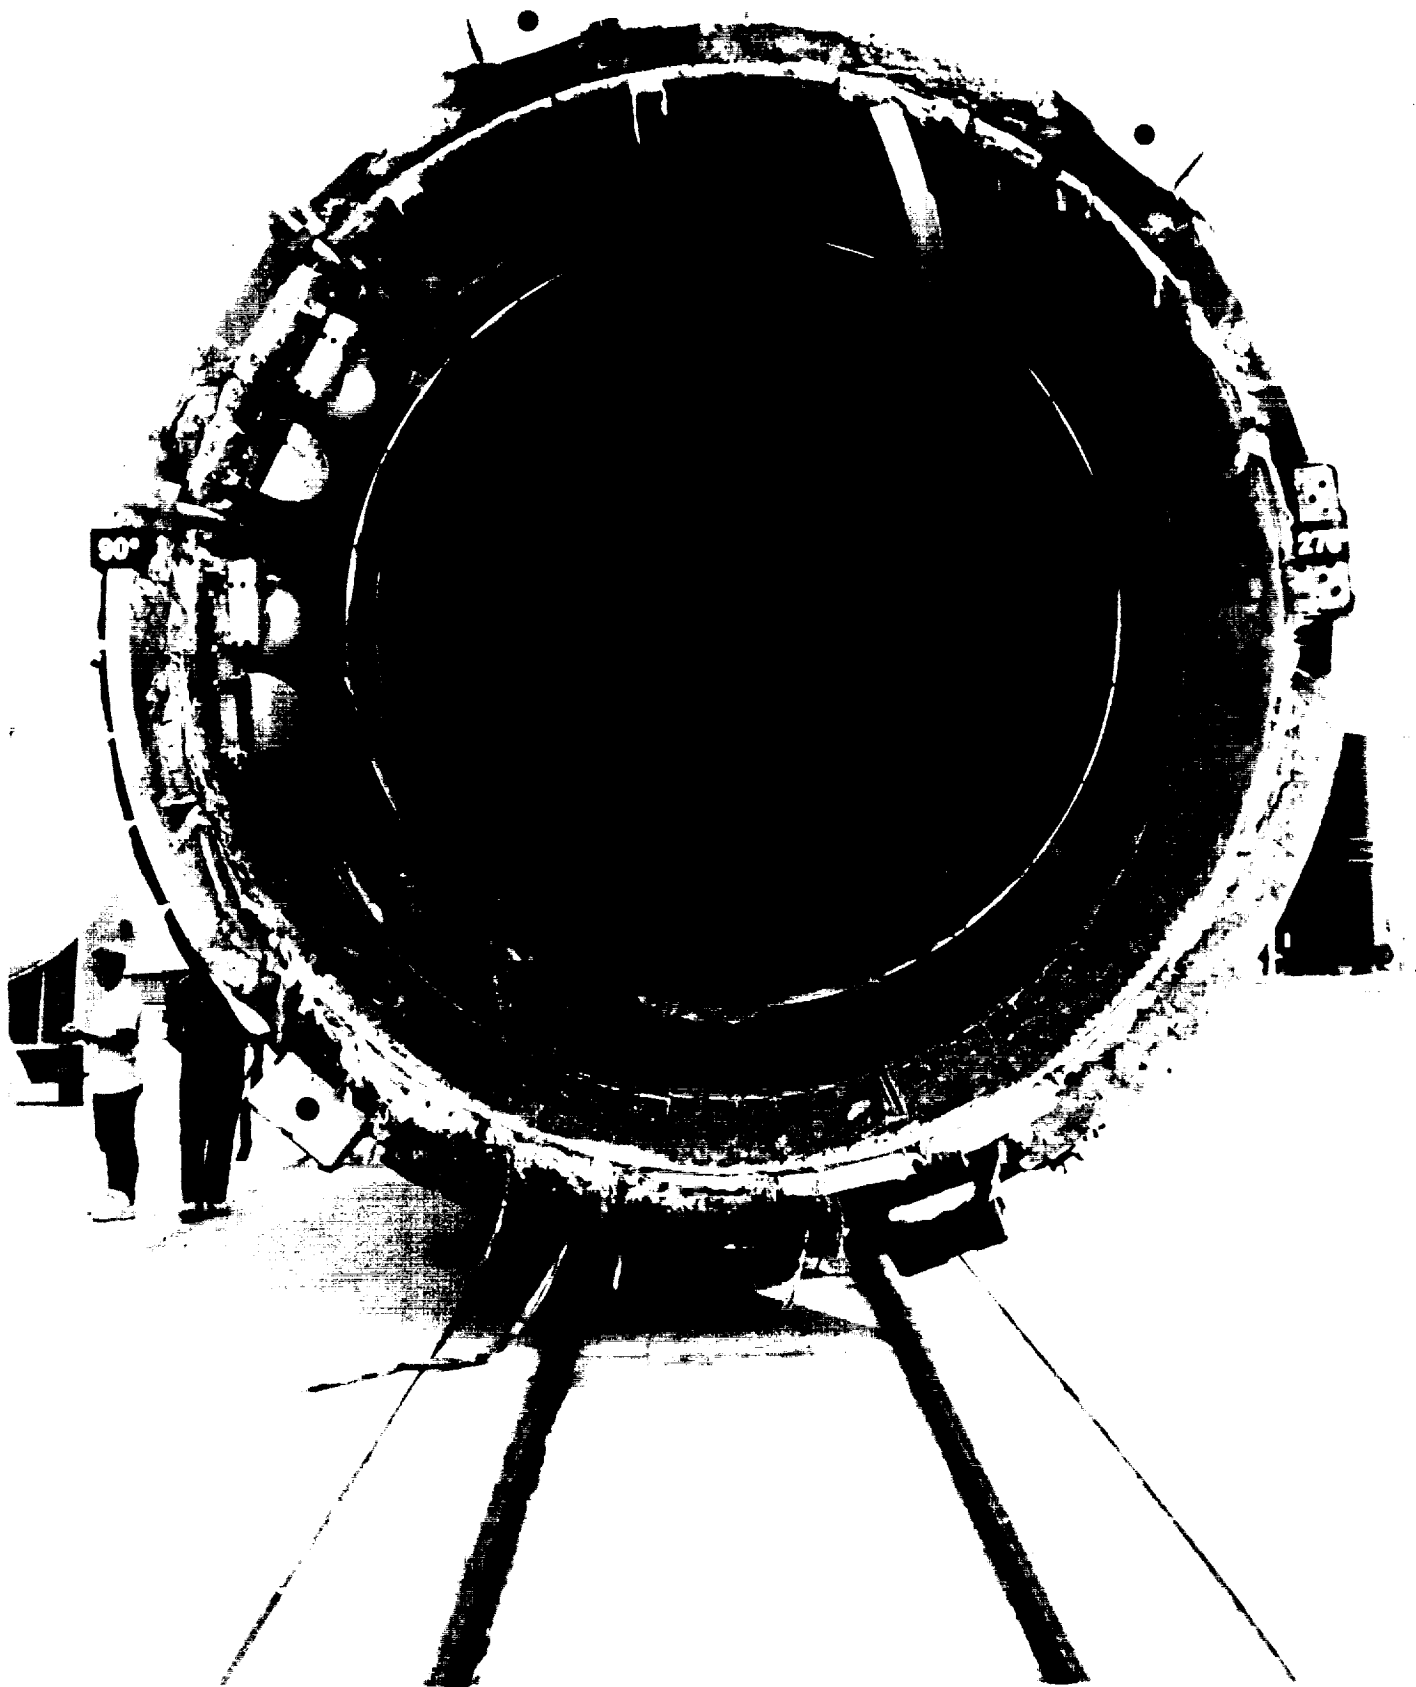
Post flight condition of LH aft skirt shows some loss of foam
around aft ring prior to water impact

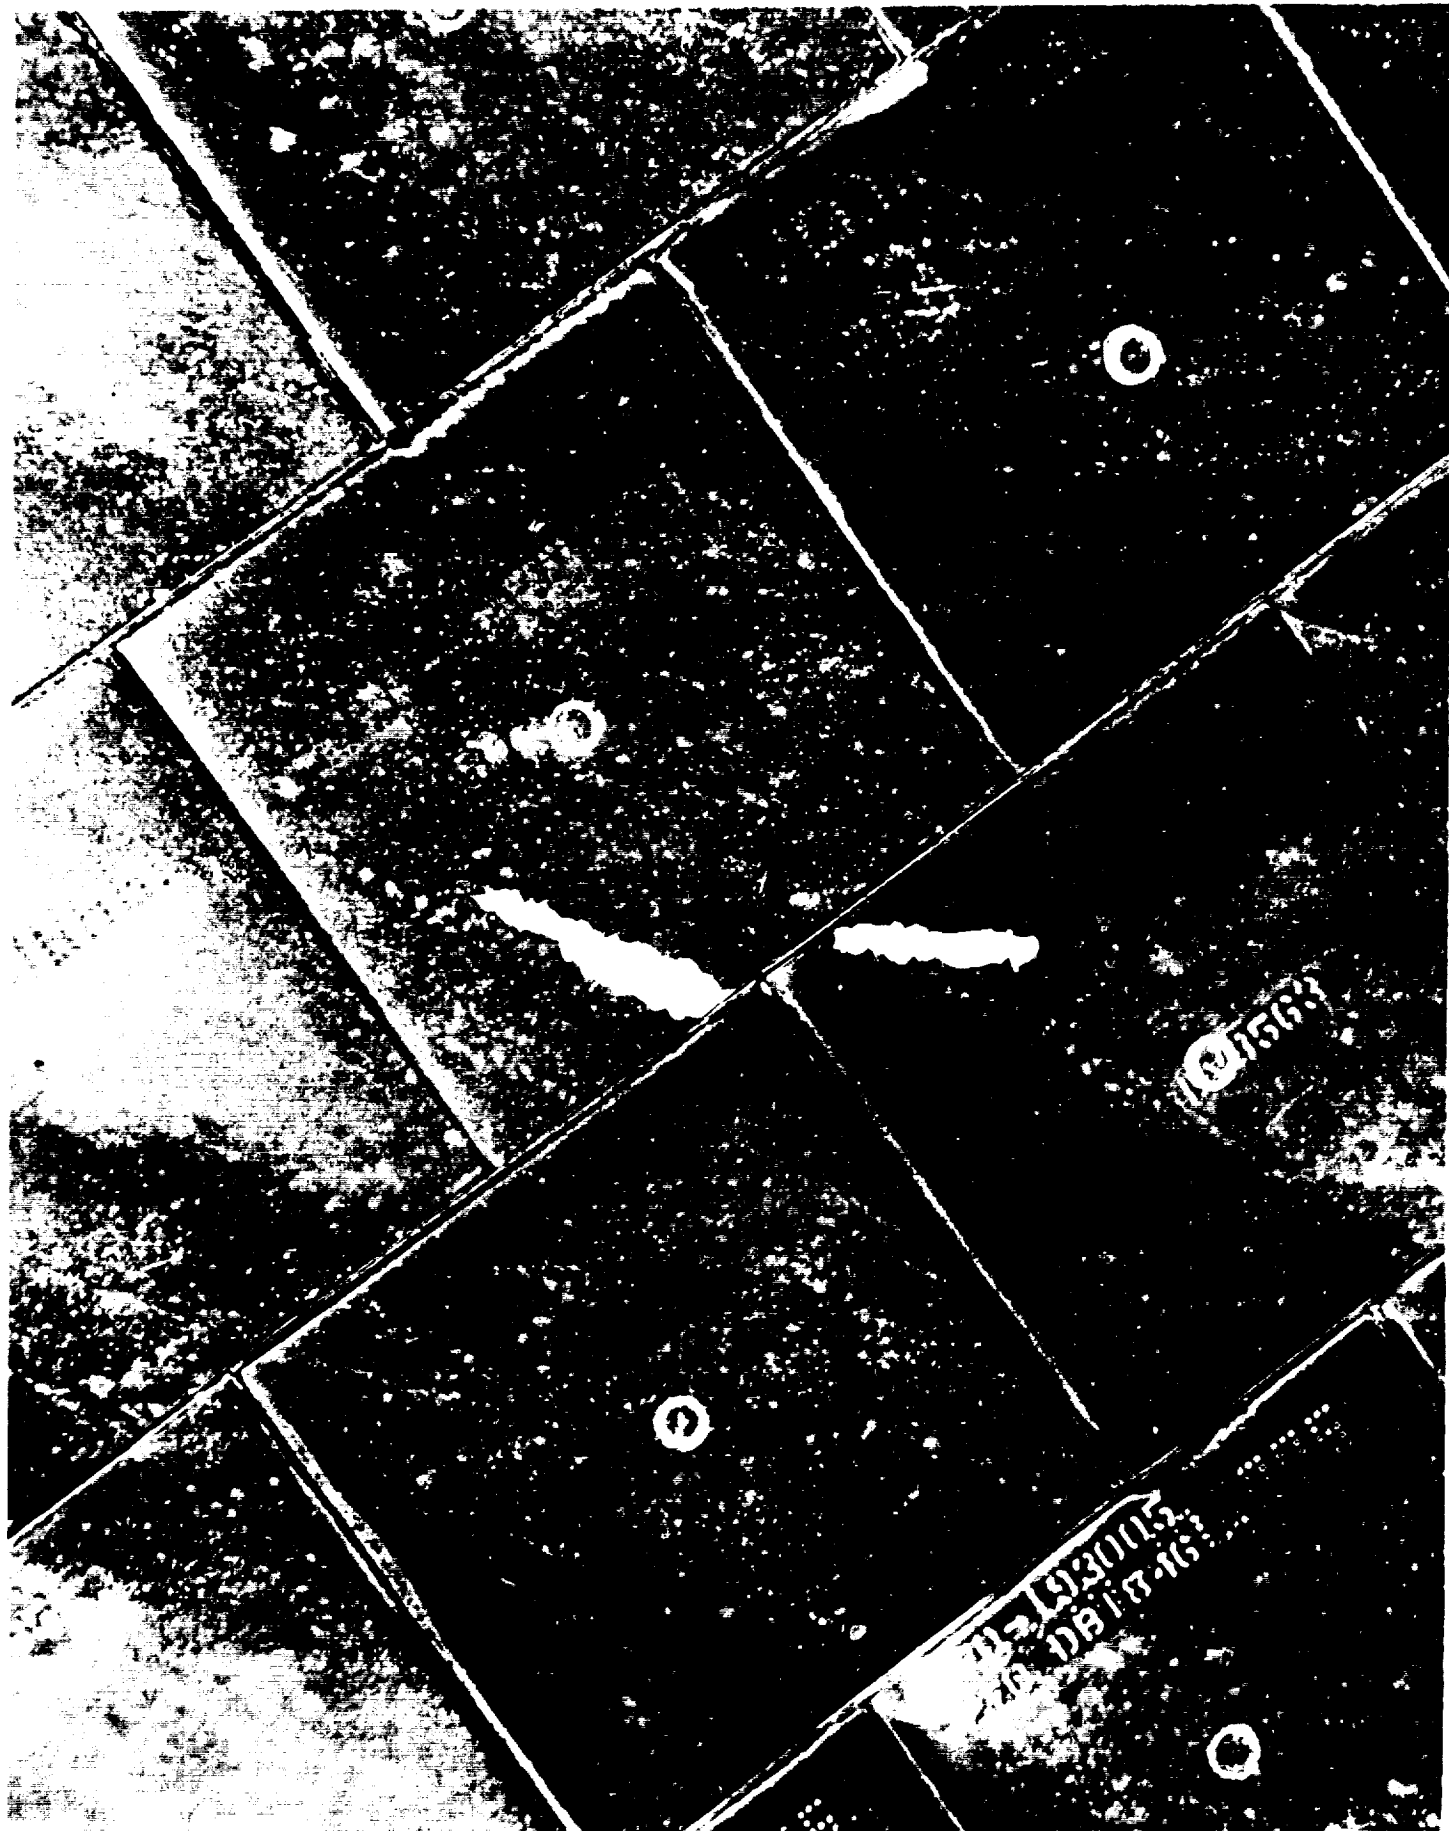
Typical tile surface coating shallow impact damage from
low density debris
198

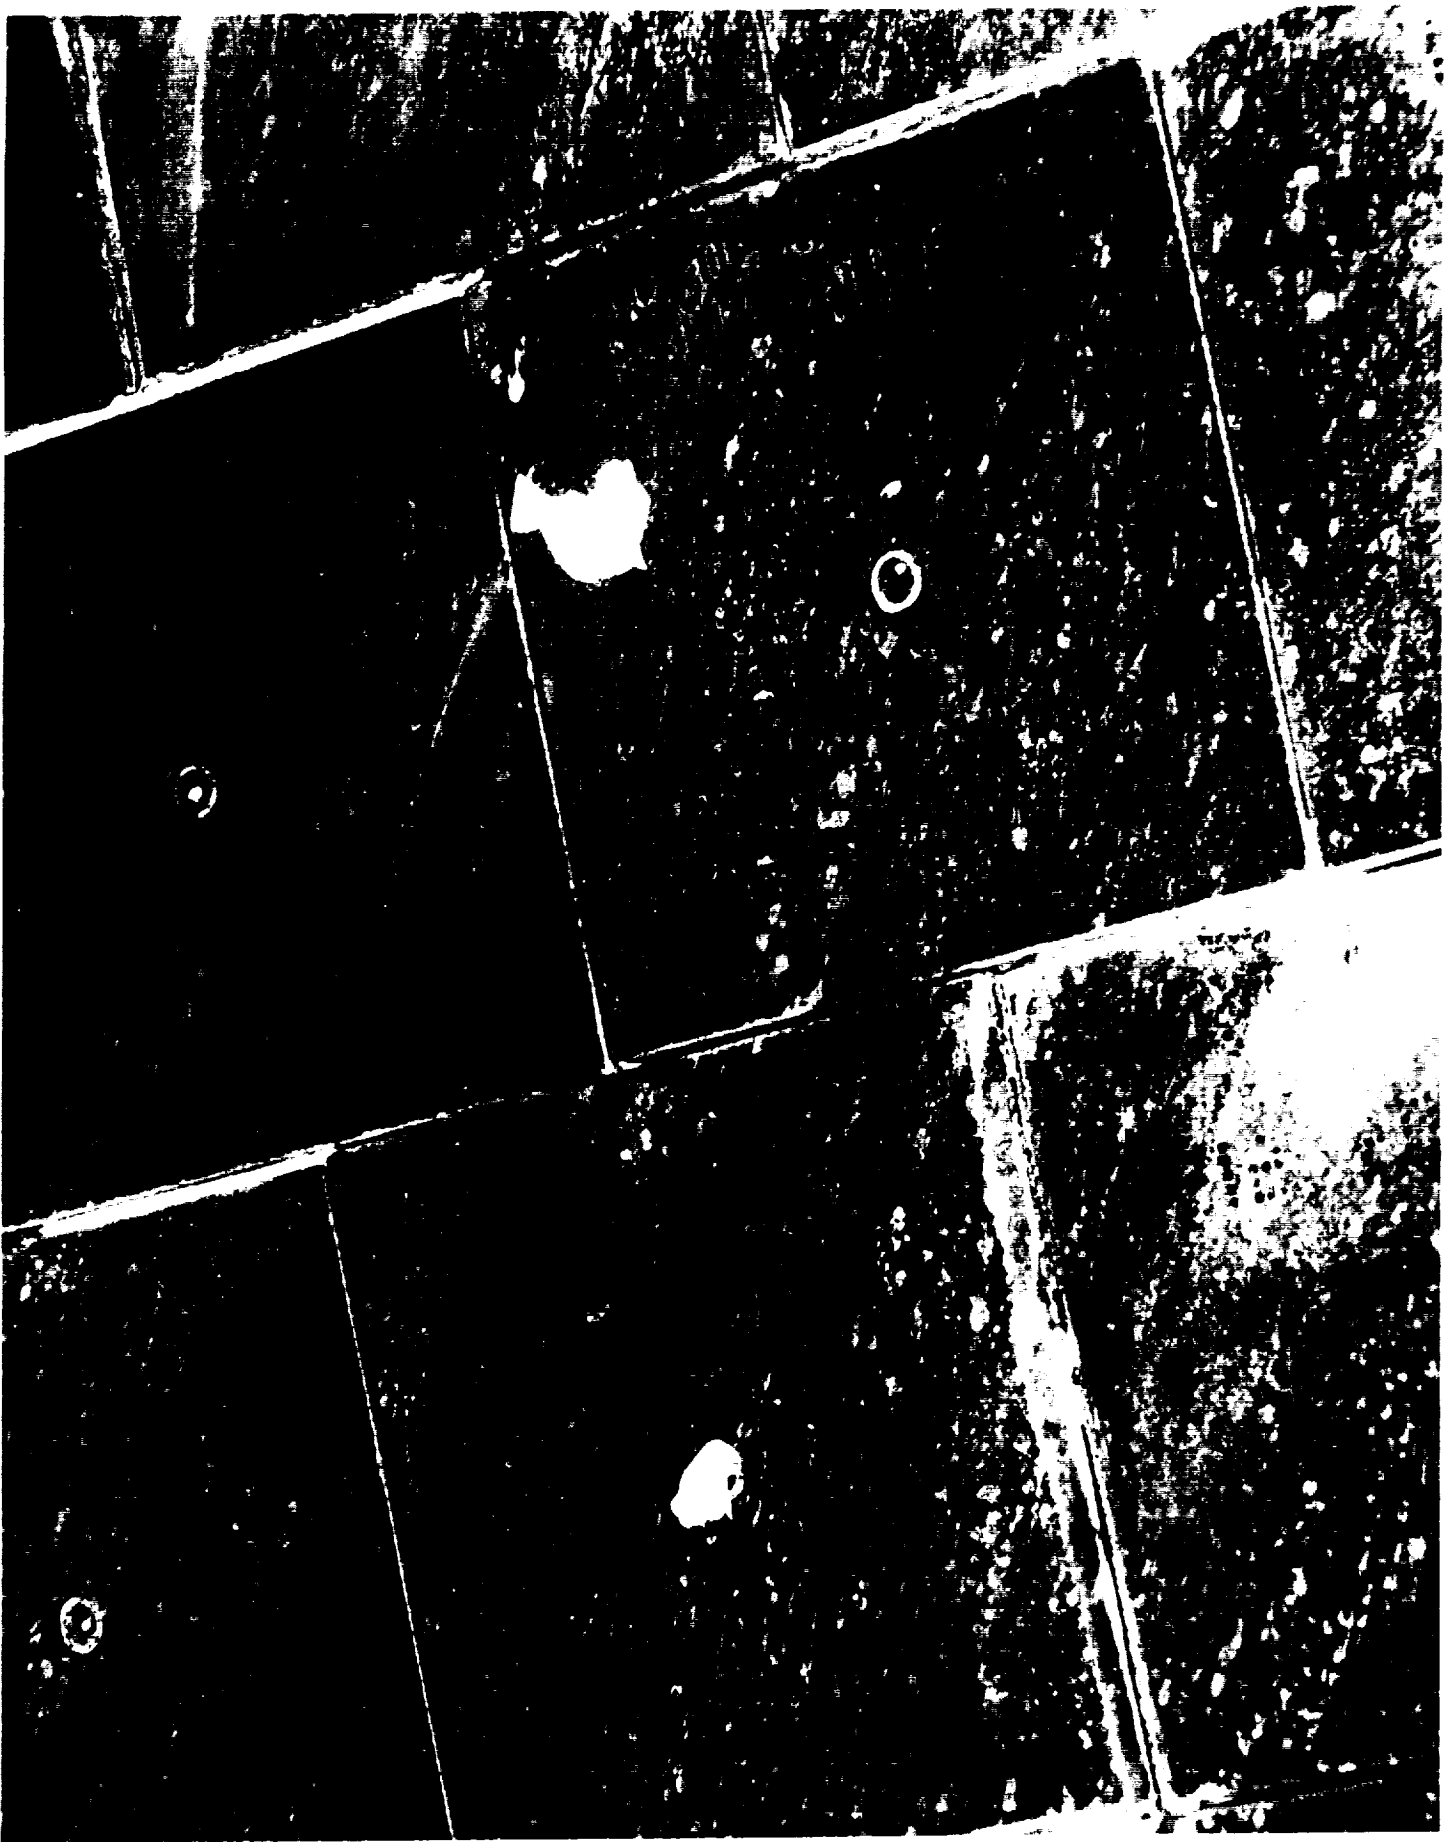
Typical tile surface coating impact damage from debris.
Note missing tile gap filler (arrow).

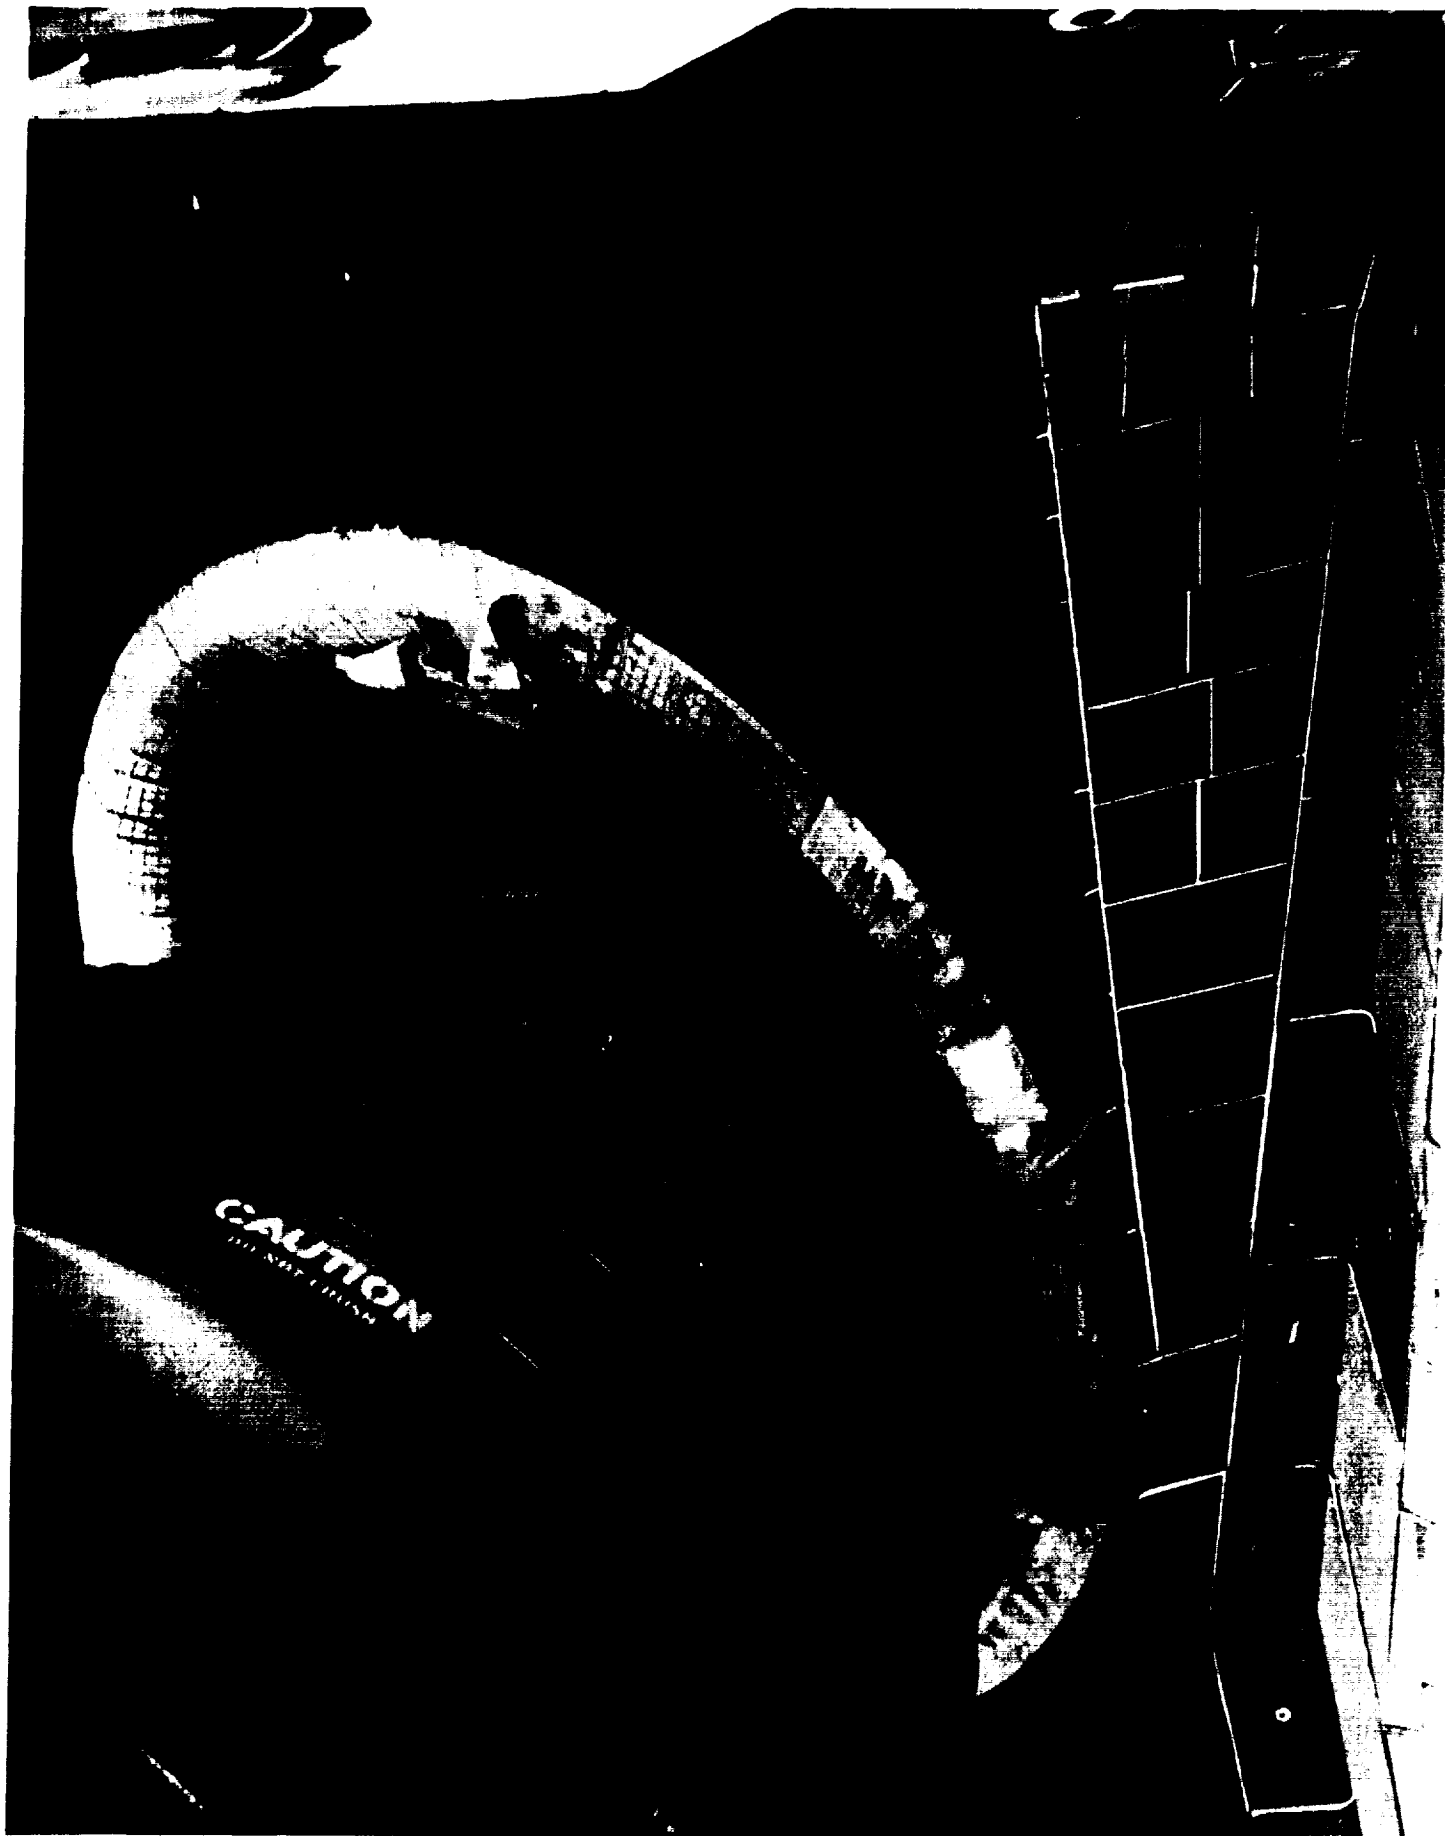
Top layer of SSME #3 blanket was loose at 3 o'clock, frayed at
6 o'clock, and missing from the 6:30 to 10 o'clock position
